Degradation of concentrating solar thermal reflectors in acid rain atmospheres

A. García-Segura^{a,*}, A. Fernández-García^a, M.J. Ariza^b, F. Sutter^c, L. Valenzuela^a

^aCIEMAT, Plataforma Solar de Almería, Ctra. Senés, km 4, P.O. Box 22, 04200 Tabernas, Almería, Spain

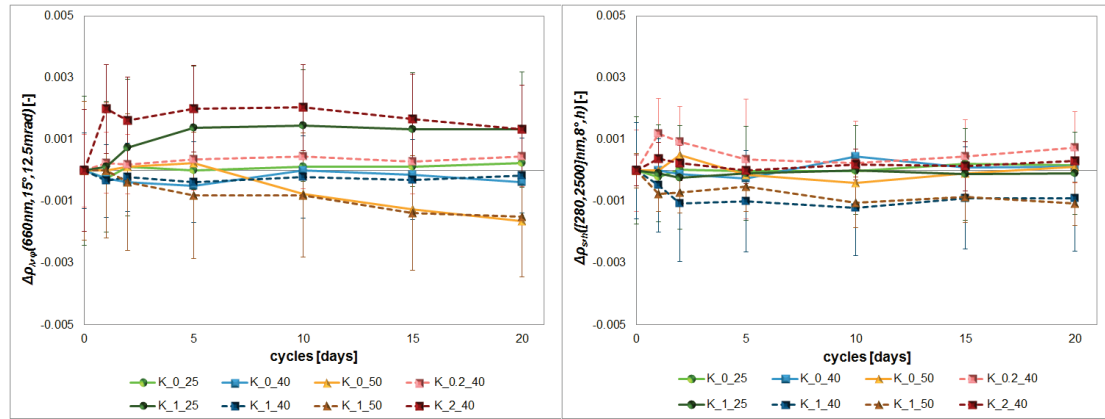
Reflectance is the best parameter for quantifying the optical quality of solar reflectors [39]. Consequently, both monochromatic specular and hemispherical reflectance were monitored during the tests. The results of the reflective area undamaged at the start of the experiment (i.e. all of the reflector surface except the area of the scratch [31]) are shown in Fig. 3. No significant changes were observed in the specular reflectance measured. Although a loss of -0.002 ± 0.002 was found at the end of the tests at the highest temperature (K_0_50 and K_1_50, shown in Fig. 3left), it is considered negligible, because it is within the measurement uncertainty of the equipment. Results were similar for the decrease in solar-weighted hemispherical reflectance, as displayed in Fig. 3right.

Fig. 3. Changes in mean increment in monochromatic specular reflectance during cycles (left) and in solar-weighted hemispherical reflectance (right) in the undamaged areas of Type 1 silvered-glass reflectors in weathering tests.

The reflectance results show that reflector surfaces were apparently not degraded by the Kesternich tests. But as already reported in previous studies [31], it is very important to analyze the optical performance of reflectors further with other tools. The samples were therefore also examined by optical microscopy on both the reflective surface and painted back to track the appearance and development of any defects. Table 3 summarizes the most significant corrosion defects found on the reflective layer of Type 1 silvered-glass reflectors at the end of testing (20 cycles). According to these microscopic results, the damage done in the SO₂-free tests was negligible, while the tests with the gas may be classified by severity as low (K_0_2_40), medium (K_1_25, K_1_40) and high (K_1_50, K_2_40) as follows.

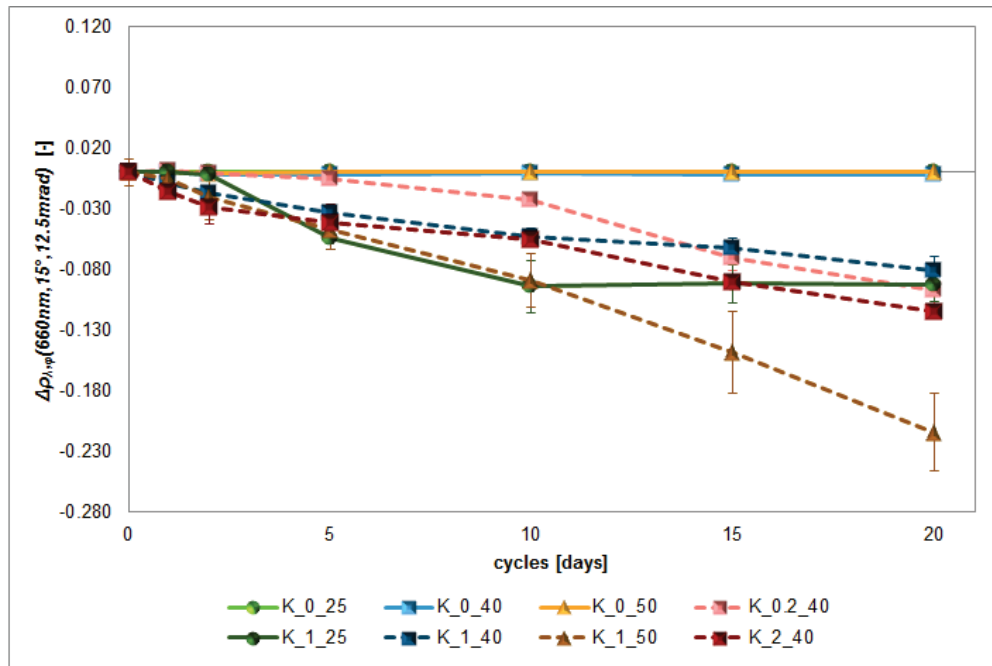
More detailed characterization was done on the reflective area near the scratch, which was expected to be the most sensitive part of the reflectors. First, monochromatic specular reflectance results are plotted over the number of Kesternich cycles in Fig. 5, showing that the tests without gas did not cause any significant change in this parameter. However, all the aging conditions with SO₂ show a similar downward trend up to a maximum decrease of -0.097±0.015, -0.093±0.014, -0.081±0.012 and -0.115±0.004 for the Tests K_0.2_40, K_1_25, K_1_40 and K_2_40, respectively. Test K_1_50 caused the greatest fall in specular reflectance (up to -0.214±0.032 after 20 cycles).

As shown in these figures, the weathering tests were classified as very low corrosion (K_0_25, K_0_40 and K_0_50), medium corrosion (K_0.2_40, K_1_25, K_1_40 and K_2_40) and high corrosion (K_1_50). Nevertheless, taking into account the corrosion features in the rest of the reflector area (Table 3), Tests K_0.2_40 and K_2_40 may be regarded as low and high, respectively. Therefore, although the corrosion severity of the tests without SO₂ is very low, and becomes more significant as the testing temperature rises, in the experiments with gas, the corrosion is much stronger, especially at high *T* and gas concentrations.

Fig. 5. Evolution over 24-hour cycles of the mean increment in monochromatic specular reflectance measured in the area of the scratch in Type 1 silvered-glass reflectors in the weathering tests.

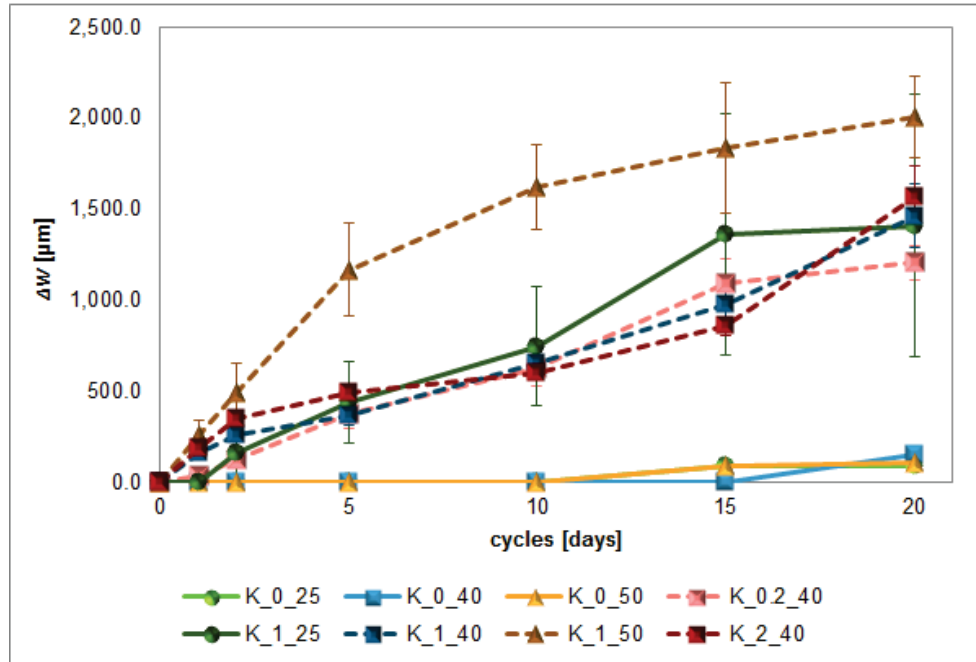
These significant reductions in reflectance were also corroborated by microscopic examination of the scratch. As may be seen in Table 5, the mean increment in scratch width (ΔW) is higher at the end of the tests with the most decrease in reflectance, which also show more corrosion. Again, the increment in scratch width (between 1200 and 1600 µm) is similar in Tests K_0.2_40, K_1_25, K_1_40 and K_2_40. On the contrary, in Test K_1_50, the scratch is so corroded that it is complicated to measure its width properly at the same magnification, as it increased by over 2000 µm. The maximum increase in width in the SO₂-free humidity tests is at least one order of magnitude lower than their counterparts in the Kesternich tests. The evolution of the mean increment in scratch width (in µm) in the tests is shown over the number of cycles in Fig. 6. Agreement between these results and the evolution of monochromatic specular reflectance shown in Fig. 5 is very good.

Fig. 6. Evolution of the mean scratch width increment (μm) on Type 1 silvered-glass reflectors during cycles in the different corrosion tests.

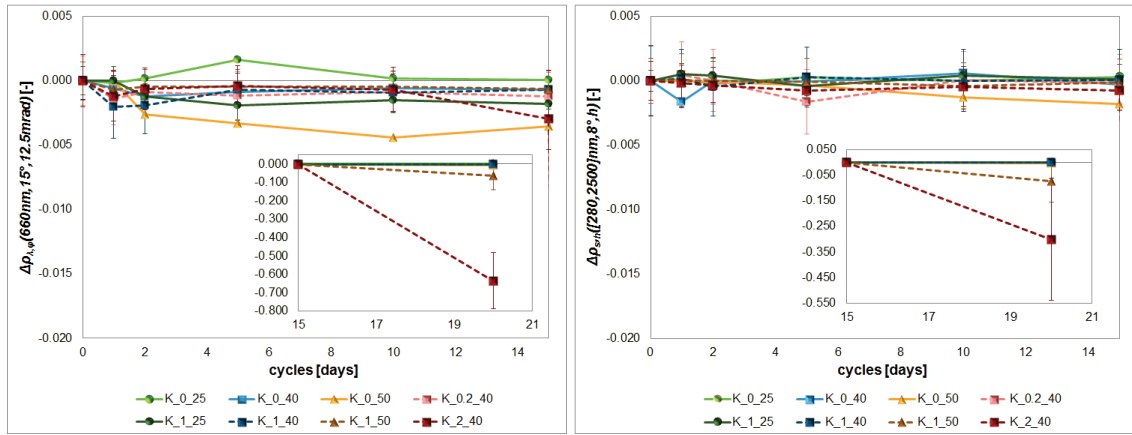
As in the first reflector material studied, monochromatic specular and hemispherical reflectance was also measured on the whole undamaged reflective area of Type 2 silvered-glass reflectors, as plotted over the number of cycles in Figs. 7left and right. No decrease in reflectance was observed after the humidity tests without gas, except for Test K_0_50, which was responsible for a loss of -0.006 ± 0.000 in specular reflectance. There was no significant reduction in reflectance either in K_0_2_40, K_1_25 or K_1_40 (classified as low and medium corrosion tests for Type 1 silvered-glass reflectors). However, the K_1_50 and K_2_40 high corrosion tests did cause a major decrease in both specular and hemispherical reflectance, especially after 20 cycles of Test K_2_40, in which there was a loss of -0.635 ± 0.153 in specular reflectance. Such strong reductions in reflectance of previously undamaged silvered-glass reflectors have not been reported for accelerated aging tests with corrosive gas [31]. Therefore, the Kesternich test can be regarded as a very aggressive corrosion test for silvered-glass reflectors, especially when extreme conditions of gas concentration or temperature are selected.

Fig. 7. Mean increment in monochromatic specular reflectance (left) and in solar-weighted hemispherical reflectance (right) over the whole reflective area of Type 2 silvered-glass reflectors during weathering test cycles.

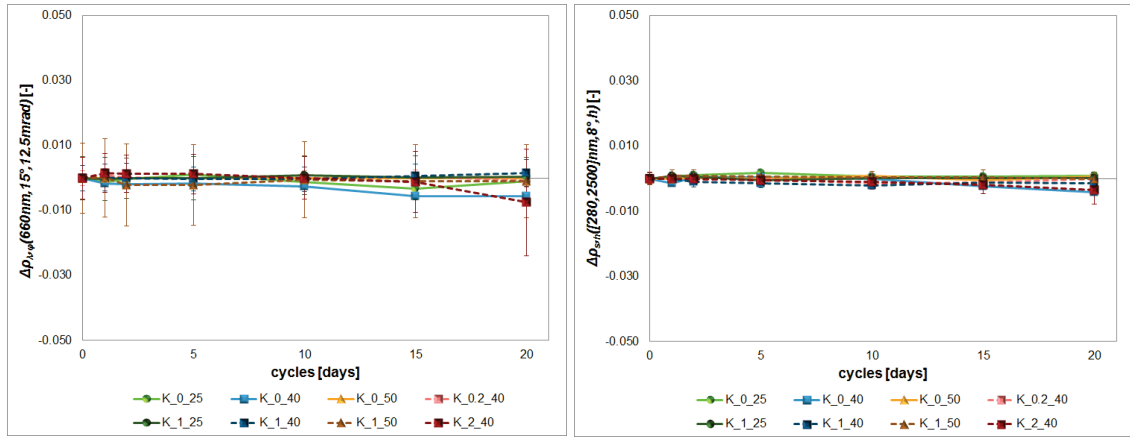
The third type of solar reflector was studied following a procedure similar to those above. First, monochromatic specular and hemispherical reflectance on the undamaged reflective area of samples was monitored during the tests. Results are shown in Fig. 9, where the greatest decrease in specular reflectance (-0.008 ± 0.016) was found after Test K_2_40 (Fig. 9left). No significant reduction in reflectance was detected in the rest of tests, although there was an anomalous loss of -0.006 ± 0.000 in specular reflectance within the range of experimental errors for the test at 40 °C without gas (K_0_40). There was no significant decrease in solar-weighted hemispherical reflectance as shown in Fig. 9right.

Fig. 9. Evolution of the mean increment in monochromatic specular reflectance (left) and solar-weighted hemispherical reflectance (right) during weathering test cycles on the originally undamaged areas of aluminum reflectors.

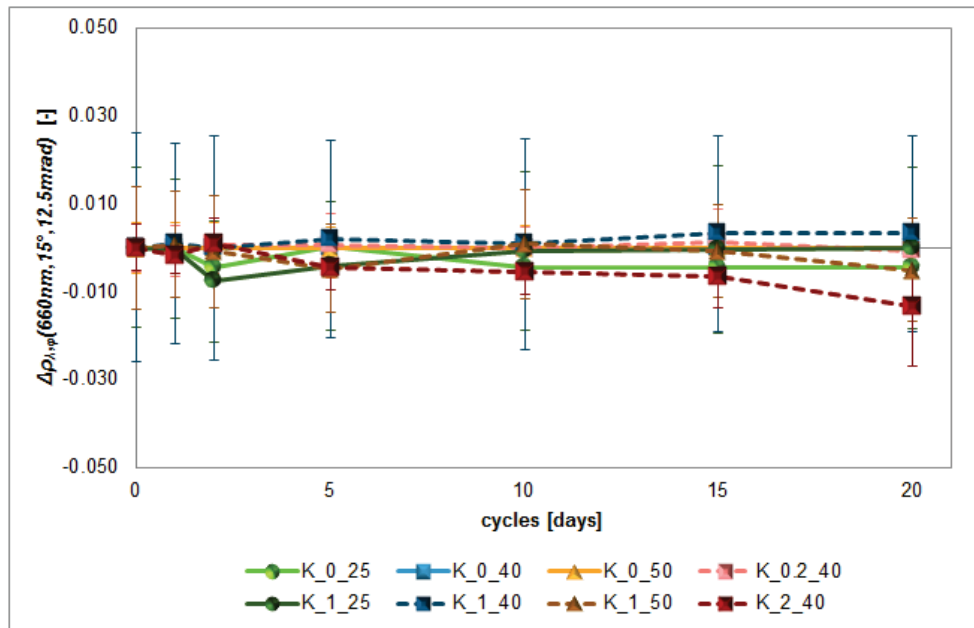
Several parameters of the scratch were analyzed in more detail, the same as for Type 1 silvered-glass reflectors. Thus, monochromatic specular reflectance was measured in the area of the scratch during the tests as shown in Fig. 10. Whereas Tests K_0_25, K_0_40, K_0_50, K_0.2_40, K_1_25 and K_1_40 did not modify reflectance, K_1_50 and K_2_40 were responsible for monochromatic specular reflectance reductions of -0.005 ± 0.012 and -0.013 ± 0.014 in the scratch, respectively. The severity of the high corrosion tests is also confirmed by microscopic measurements of the scratch width (see Table 9 and Fig. 11). The largest changes in scratch width were found after K_2_40 and K_1_50, followed by K_1_40 and K_0.2_40. However, no significant modifications in scratch width were observed after the rest of the tests, even those without gas and the K_1_25 test, in spite of the spots that were observed at the end of this ambient temperature test with a medium SO_2 concentration (see Table 9).

Fig. 10. Evolution of the mean increment in monochromatic specular reflectance over 24-hour cycles measured in the area of the scratch on aluminum reflectors in the weathering tests.

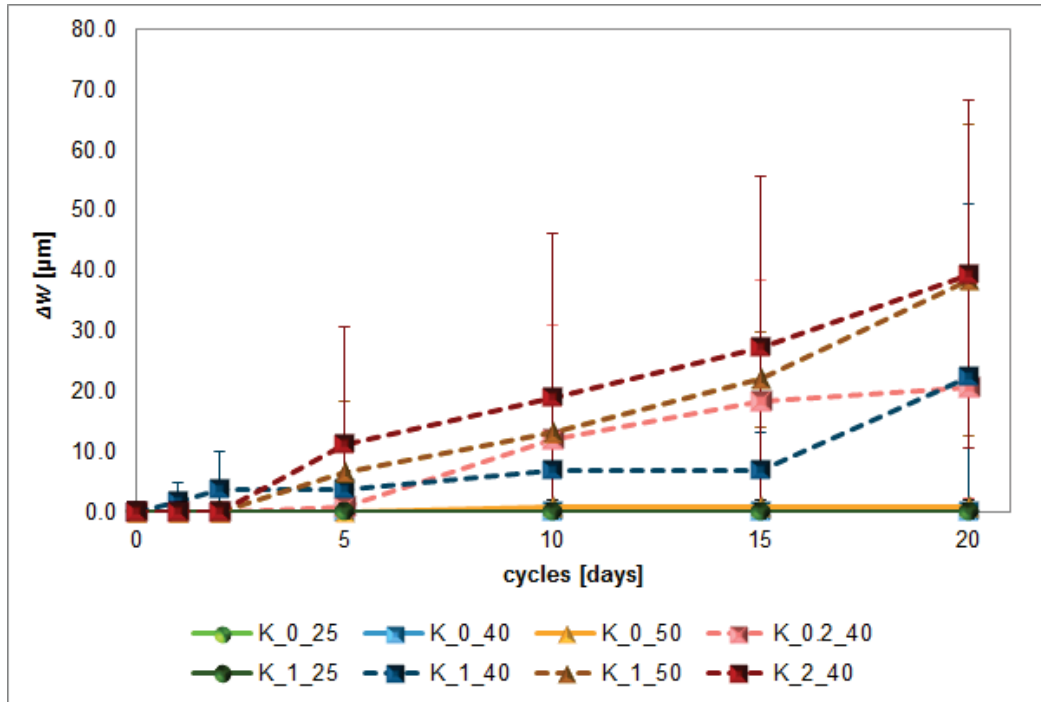
Fig. 11. Evolution of the mean increment in scratch width (μm) in aluminum reflectors over corrosion test cycles.

Summarizing, aluminum reflectors were generally not as corroded by the Kesternich tests as silvered-glass reflectors. As reported in previous studies, degradation of aluminum reflectors is rather slow, mostly because of their protective SiO_2 layer [23], and entails various factors including moisture, abrasion and pollutants during long exposure [13]. In this study, only the two extreme tests (K_2_40, with the highest SO_2 concentration, and K_1_50, with the highest temperature) caused any corrosion detectable under the microscope, but it was harder to detect by monochromatic specular reflectance. In light of these results, both the corrosive gas concentration and its synergism with temperature and humidity are key factors to be considered in aluminum reflector durability studies, as the most corrosion was found in the test with the highest gas concentration and intermediate temperature (K_2_40).

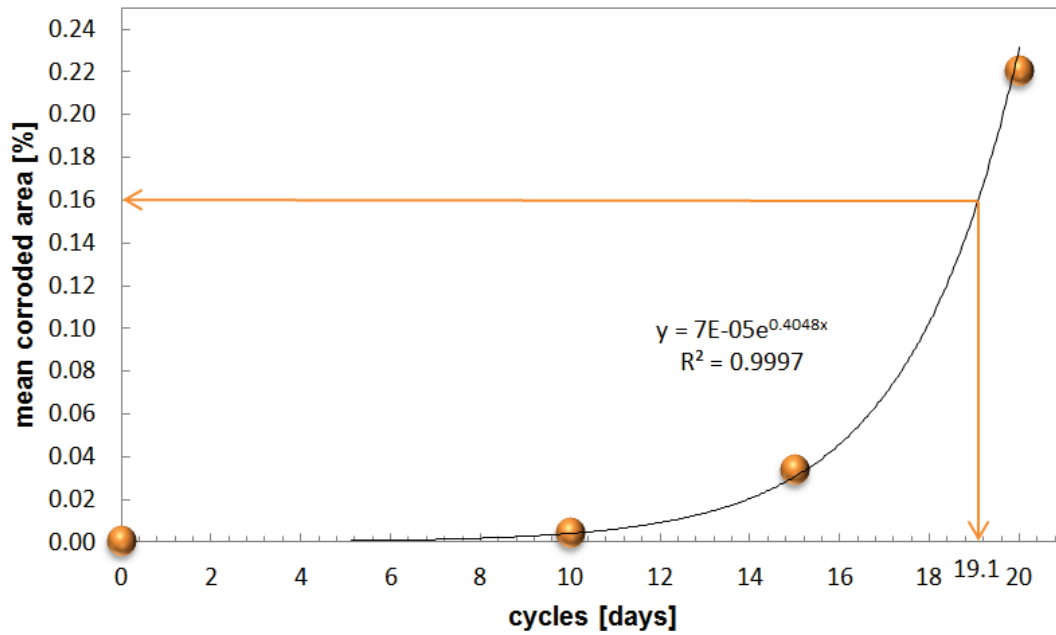
The growth of corrosion spots on Type 1 silvered-glass reflectors was monitored during the K_2_40 test cycles by microscopic measurement. Thus, the areas of representative spots could be calculated, and by combining them with the total number of spots, the mean corroded area (per three specimens during the test cycles) was arrived at. Fig. 13 shows the mean area of corrosion spots (%) on Type 1 silvered-glass reflectors over the number of test cycles. The measurements are marked with orange circles and the solid line is the best fit found with a determination coefficient of 0.9997, which corresponds to an exponential function as shown in Eq. (1):

Fig. 13. Growth of mean area of corrosion spots (%) on Type 1 silvered-glass reflectors during K_2_40 test cycles.

This correlation enabled the K_2_40 test time (24-hour cycles) equivalent to real on-site degradation to be found, i.e. 0.16% after 19.1 test cycles (458 h), as marked with orange arrows in Fig. 13. As the real exposure time was three years, the acceleration factor would be 57 for the study exposure site. These rough calculations, which are a first step in the correlation of accelerated tests with real outdoor exposures, may be very valuable, since such estimates for commercial CSP silvered-glass reflectors are rarely found in the literature.
